Water Compliance Inspection Report

Name and Location of Facility Inspected (For industrial users discharging to POTW, also include POTW name and NPDES permit number) North Star Terminal & Stevedore Co., LLC 790 Ocean Dock Road Anchorage, AK 99501	Entry Time/Date 9:20AM 10/04/16	Permit Effective Date 04/01/2015
	Exit Time/Date 11:45AM 10/04/16	Permit Expiration Date 03/31/2020
Name(s) of On-Site Representative(s)/Title(s)/Phone and Fax Number(s) Steve Black, Anchorage Operations Manager (907) 263-0121 steveb@northstarak.com	Other Facility Data (e.g., SIC NAICS, and other descriptive information) NAICS 488320 - Marine Cargo Handling ADEC MSGP Inspection	
Name, Address of Responsible Official/Title/Phone and Fax Number Steve Black, Anchorage Operations Manager (907) 263-0121 North Star Terminal & Stevedore Co., LLC 790 Ocean Dock Road Anchorage, AK 99501	Contacted <input checked="" type="checkbox"/> Yes <input type="checkbox"/> No Lat: 61.228052 Long: -149.895144

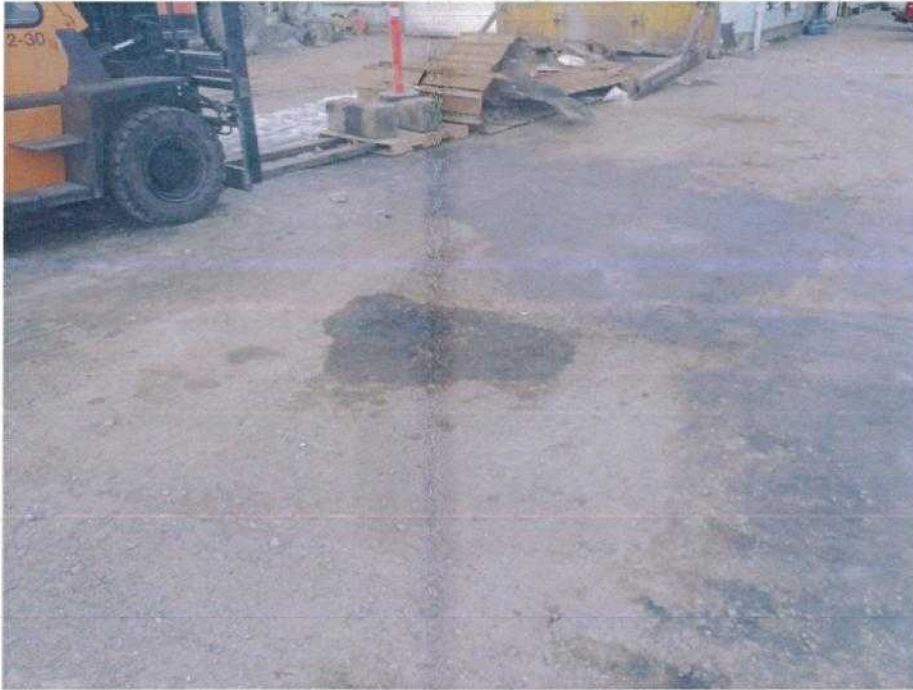
1. Oil on ground back corner of shop. Needs cleaned up and Aqau Zyme applied when weather warms up.

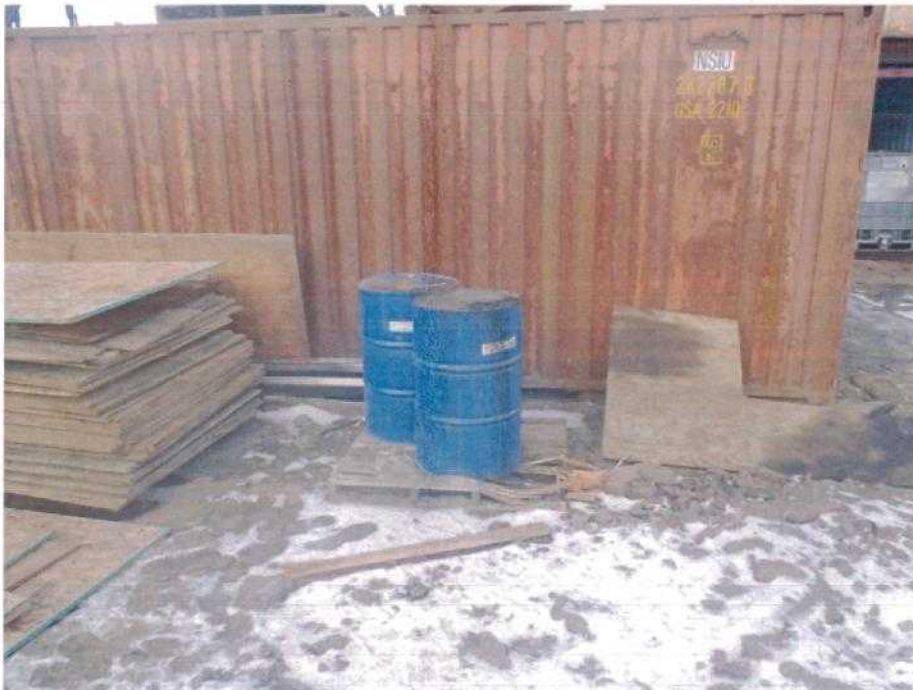
2. Waste oil drum sitting outside of container in the weather with oil on top which is running onto the ground. Needs cleaned up and moved inside.

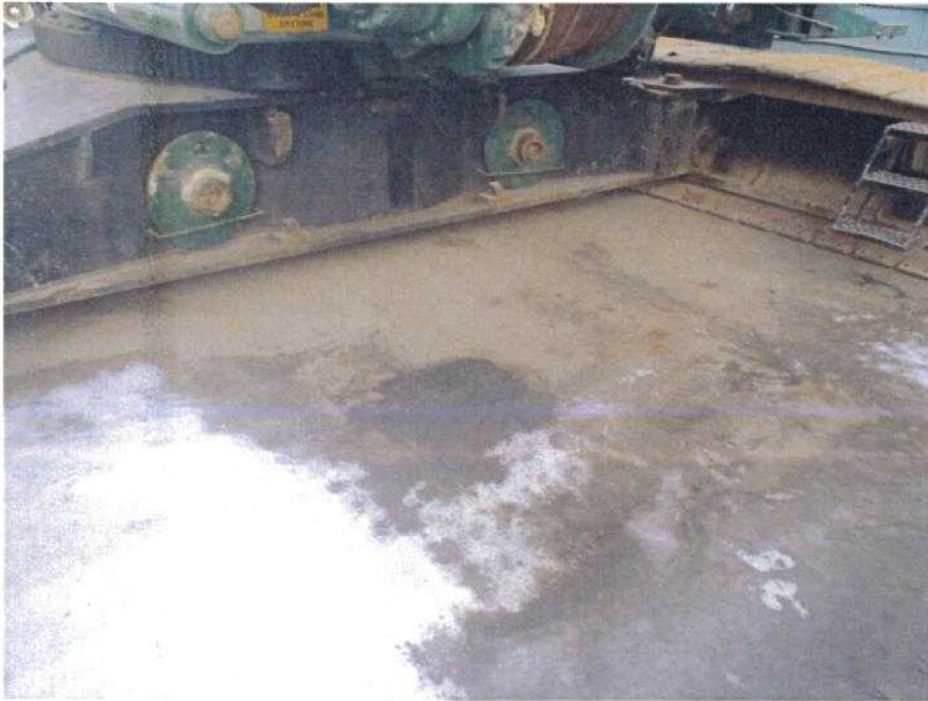
3. Oil on ground under new M-250. Needs cleaned and Aquazyme applied when weather warms up. Need to put duck pond or something under work areas where oil will drip down during repairs.

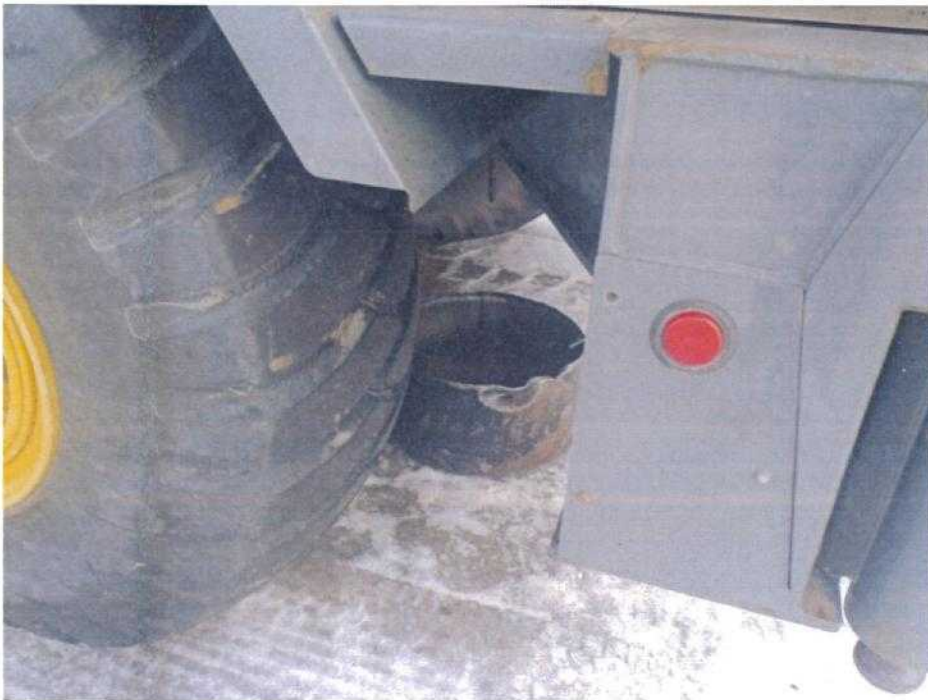
4. Proper use of putting something under work to catch run-off oil.

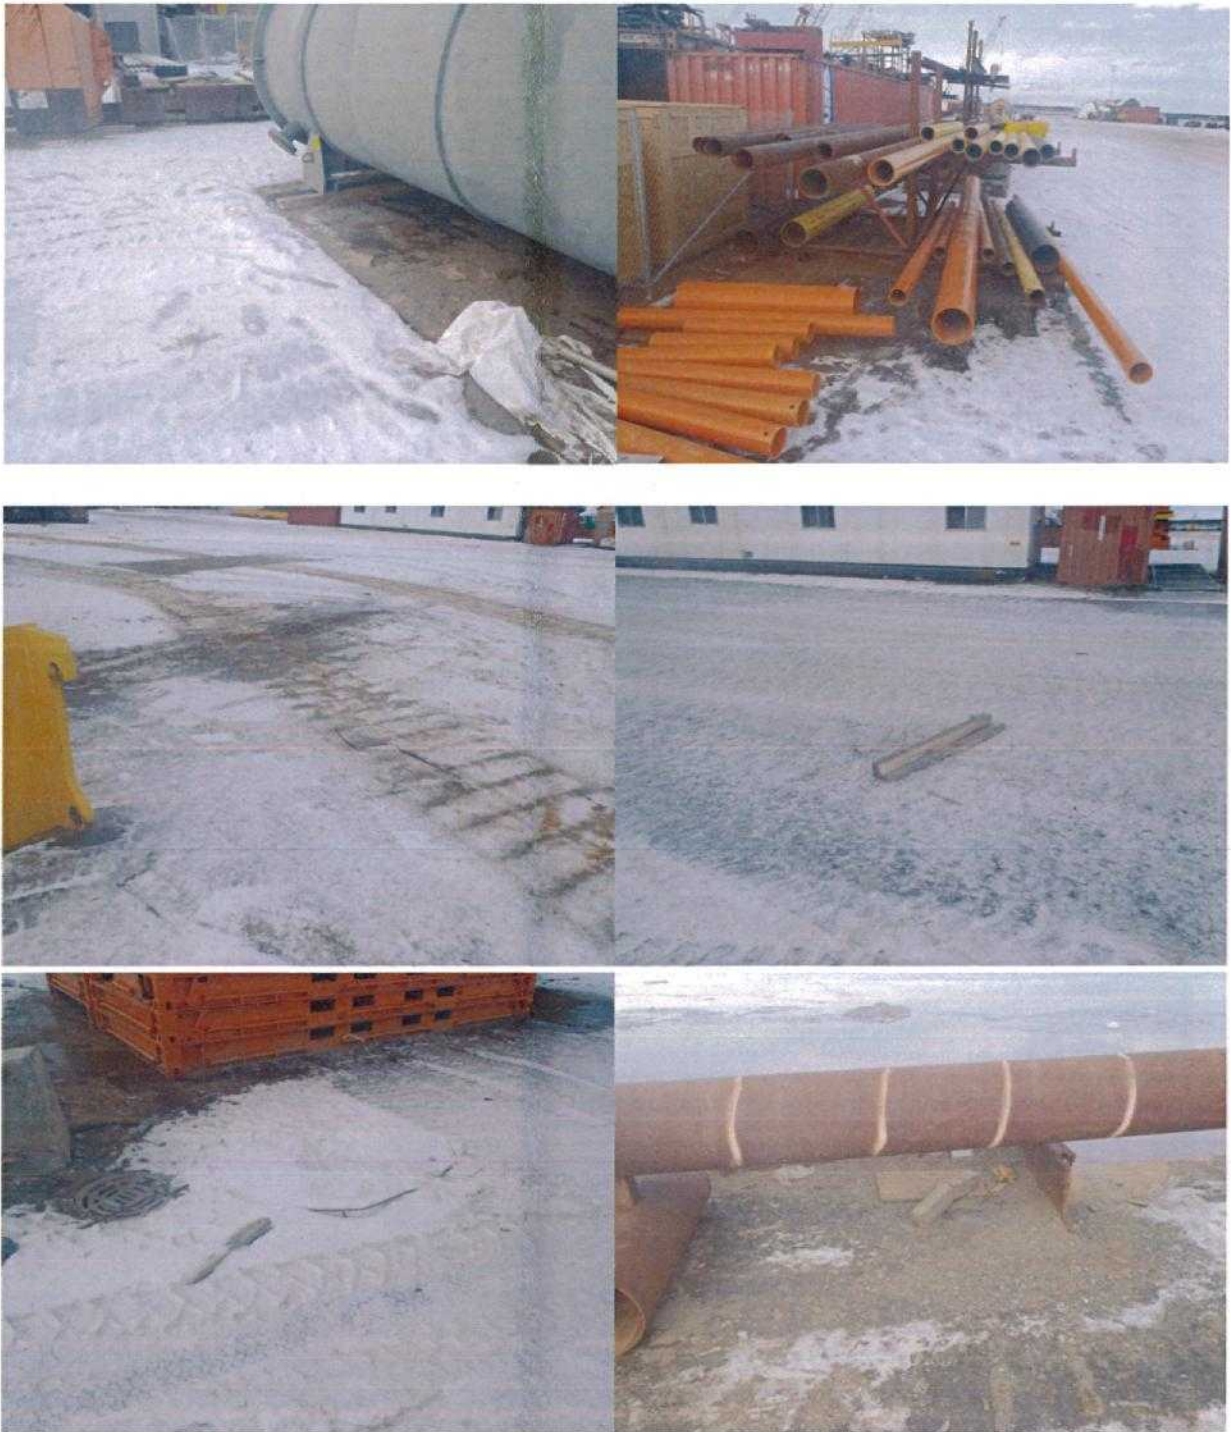
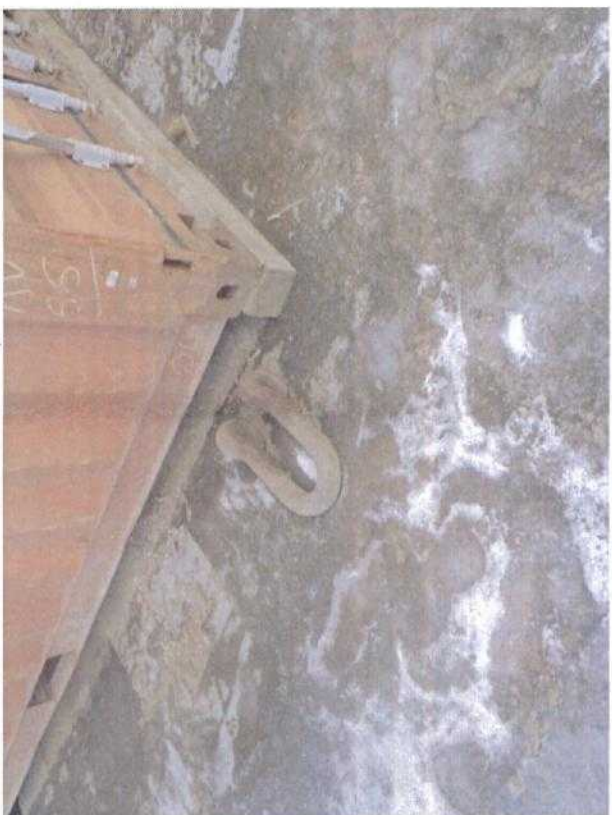
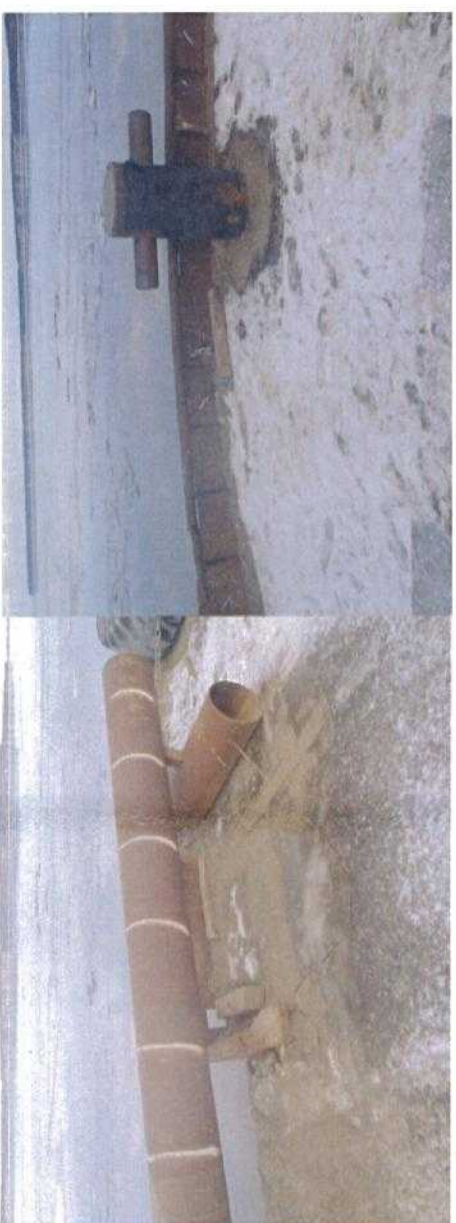
5. The next several pictures are of garbage on the ground or items that need to be picked up.

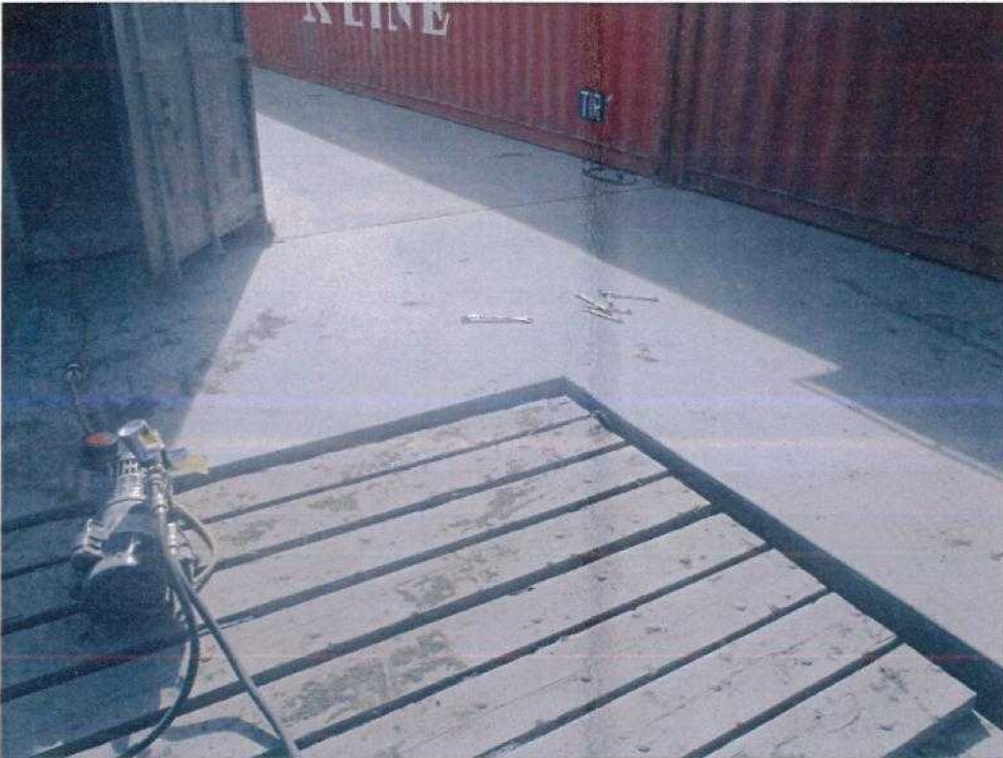
1. Tools left lying on the ground.

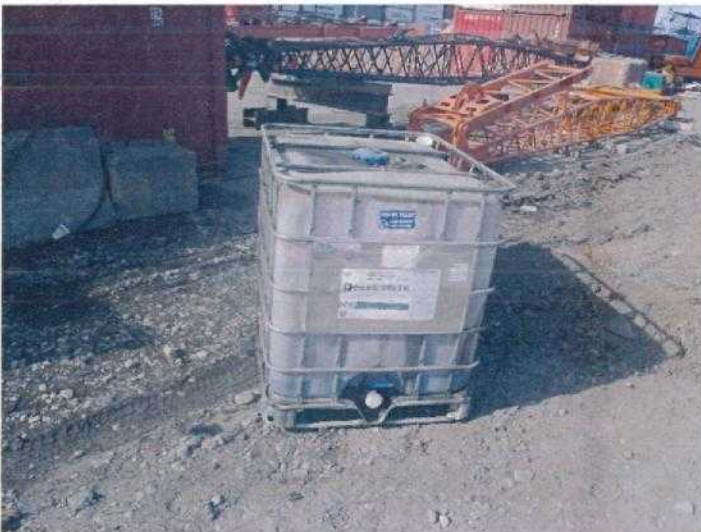
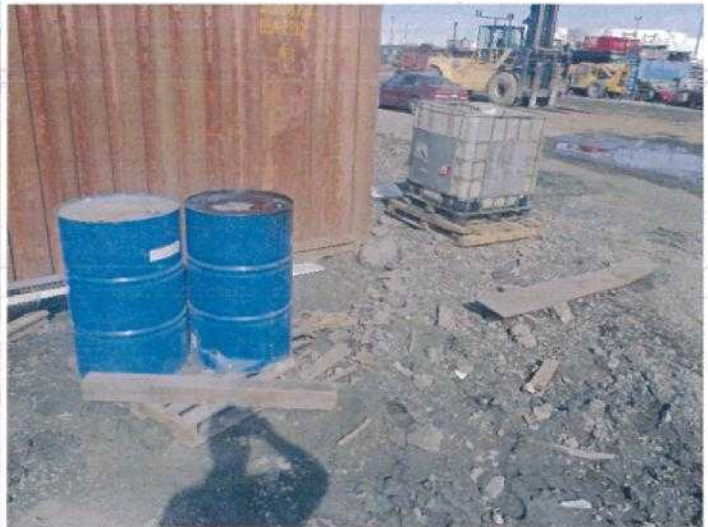
2. Waste oil containers left out in the weather. Need to be inside where rain can't wash potential oil on top into the ground. Per Mark, the two paint waste drums are to be topped off and called in for disposal by the end of the week. Whoever is shuffling waste oil tanks need to make sure all tanks are put away.

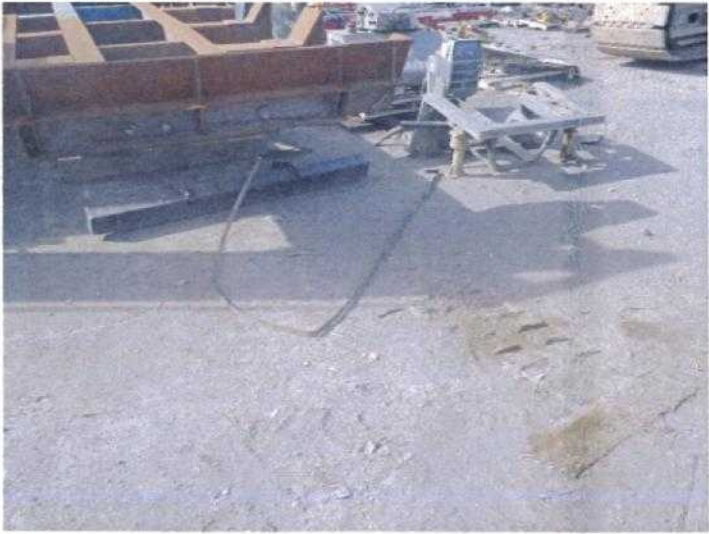
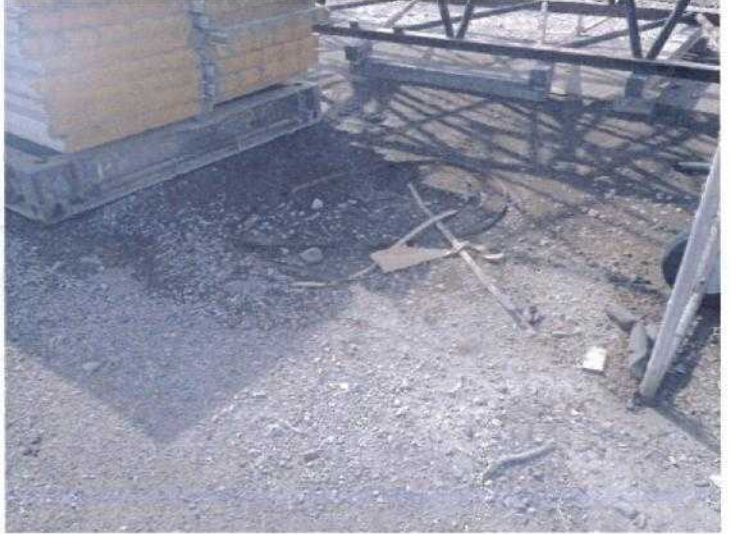
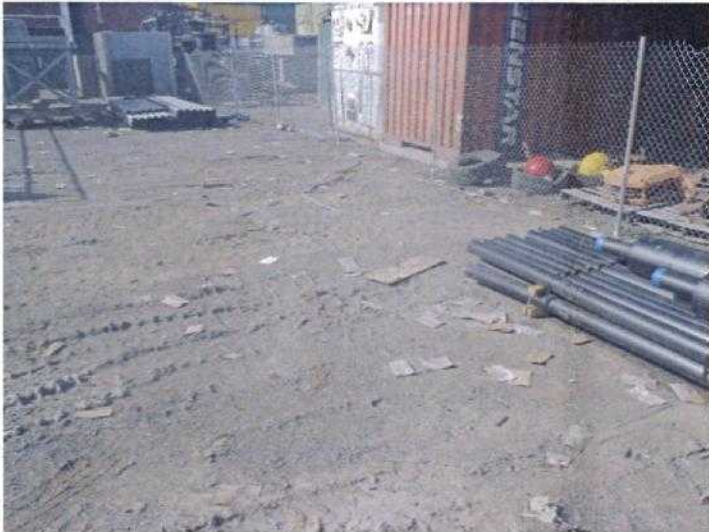
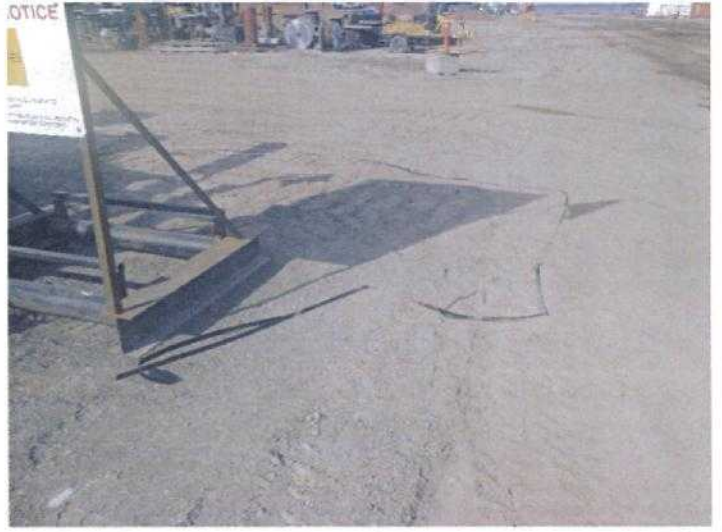
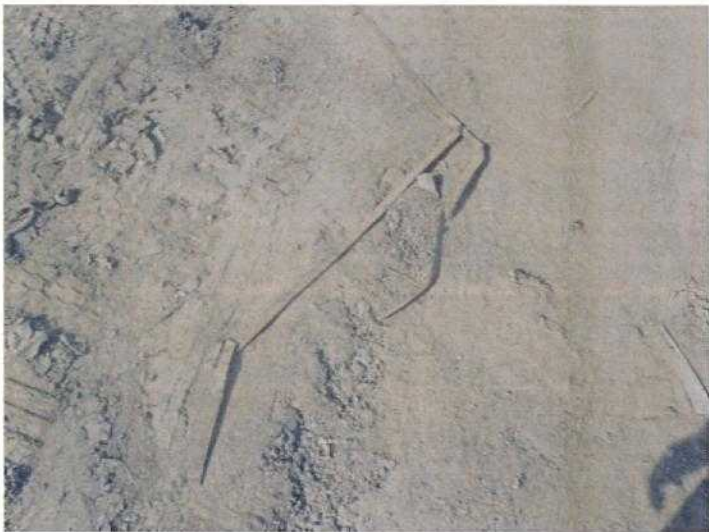
3. Banding, dunnage and miscellaneous garbage needs to be cleaned up from the yard.

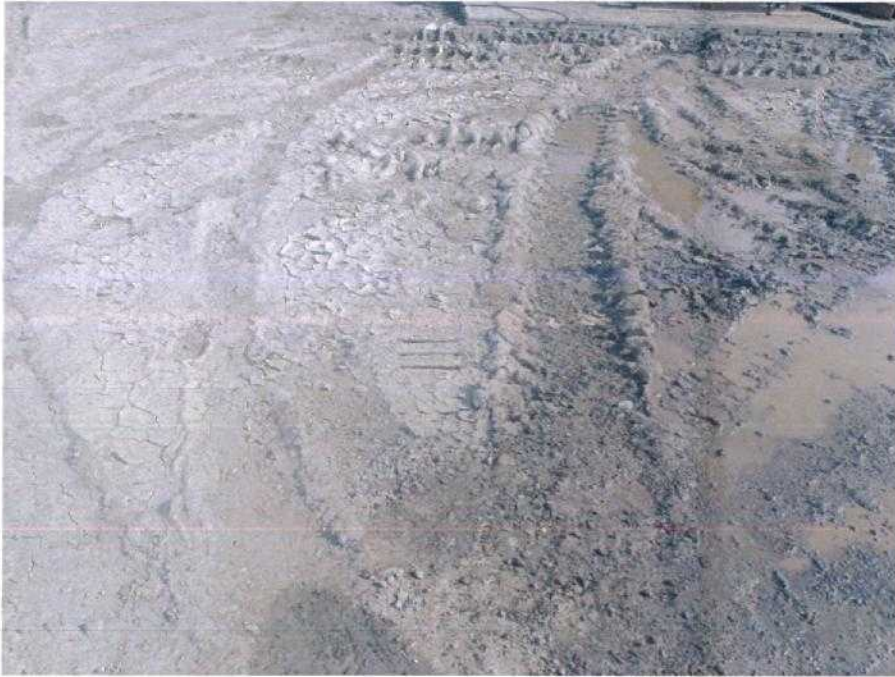
4. Need to clean up around drain and put oil absorbent pads around. Put some pads in catch basin. It's a small basin and it already drains slow so at least we will catch more of the oil from the "wash bay". If it fills up too fast with mud we will try something else. We need to try something to keep the wash bay contaminants out of the storm drain. Rick/Vern, flush the drain some with the water truck. It will take a few times at it, then put some oil absorbent boom in and around the drain. Scratch out a little bit of a groove /trench around the drain so at least one ring of boom is lower than the top of the drain.

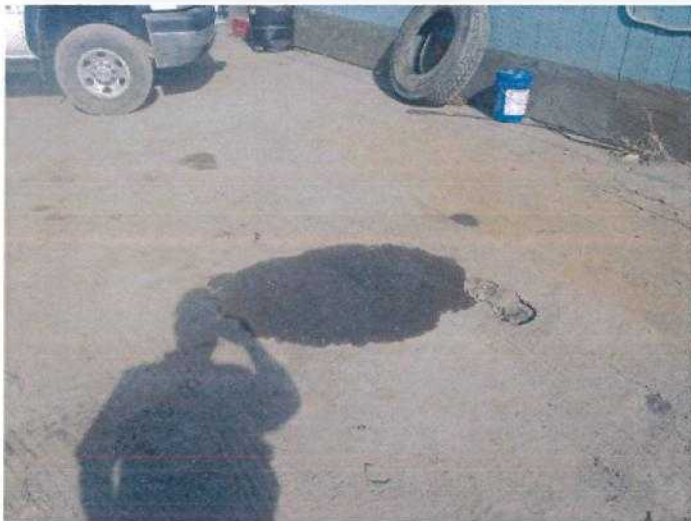
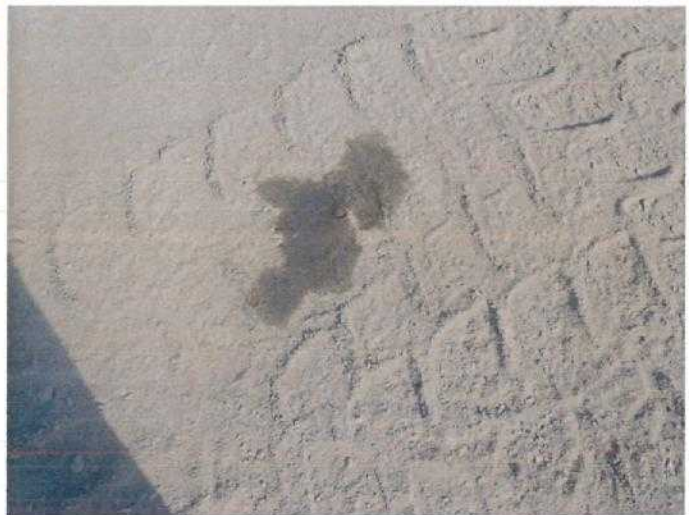
5. Oil spills are not getting cleaned up not sprayed with the AquaZyme. New year...same rules. The AquaZyme helps what does run off into the storm drain not have as negative of an effect on the environment. There are two sprayers in the shop in the room with the pressure washer. The water AquaZyme solution in the sprayer is more effective than sprinkling AquaZyme directly on spills. Start using it.

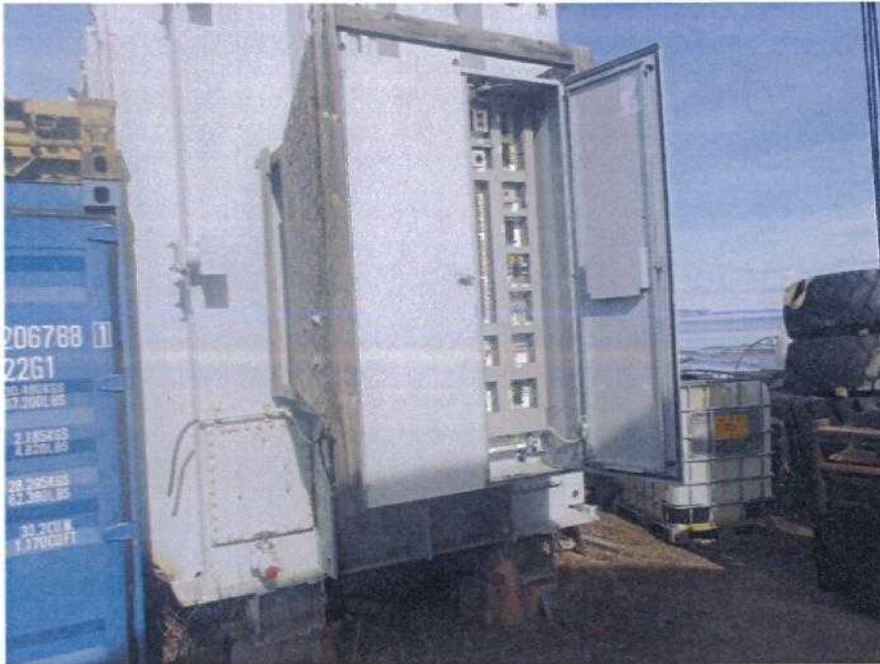
6. Door was wide open. Not sure for how long or who opened it. Regardless, when you see something open like this, take the time to close it. That goes along with equipment doors left open.

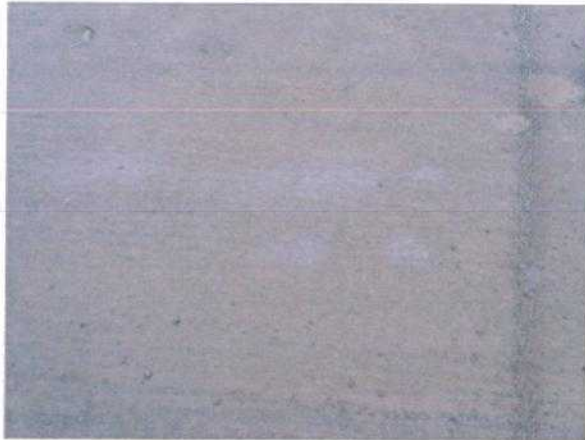
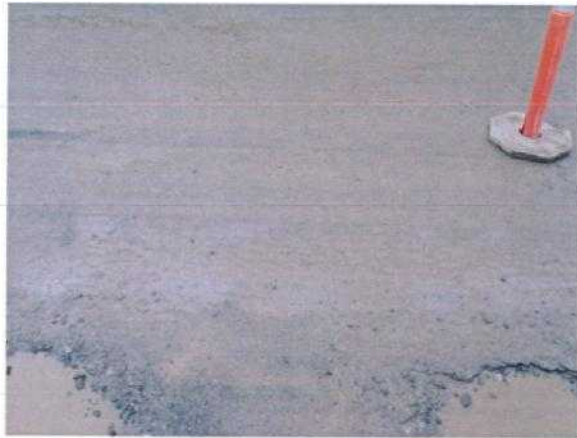
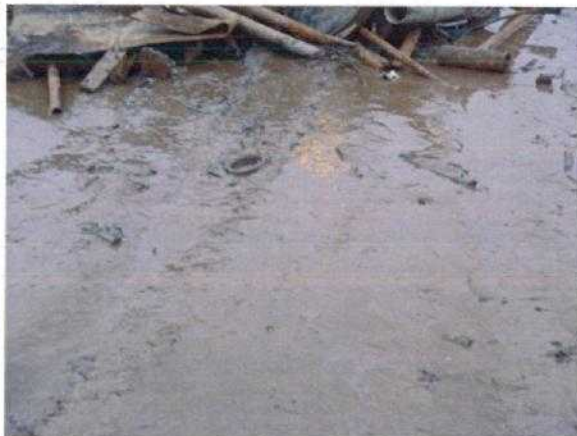
During my inspection I noticed a substantial number of oil droplets through the yard. I followed them from the driveway to the scrap yard. Schnitzer's truck that was hauling scrap from the rail spur to the scrap pile had a hydraulic line leak. Schnitzer's mechanic (Dave) came in with the demo-dump while I was still in the yard so I pointed the oil out to him and we found the leak on the back of their green truck.

Below are some of the pictures I took through the yard. My only complaint here is why nobody else checked this out sooner? We need to be more aware of fresh oil on the ground and get to the root of the problem ASAP. As I've stated several times, our water samples are 10 times over the ADEC benchmarks. Those scrap piles are a big culprit, but not the only ones.

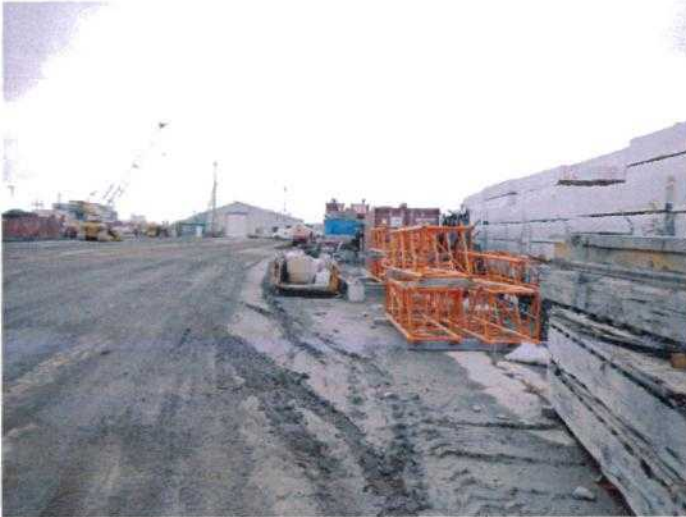
Photo #:01

Description: Facing west. Photo of a material storage area from the east corner of the property near the entrance to the facility.

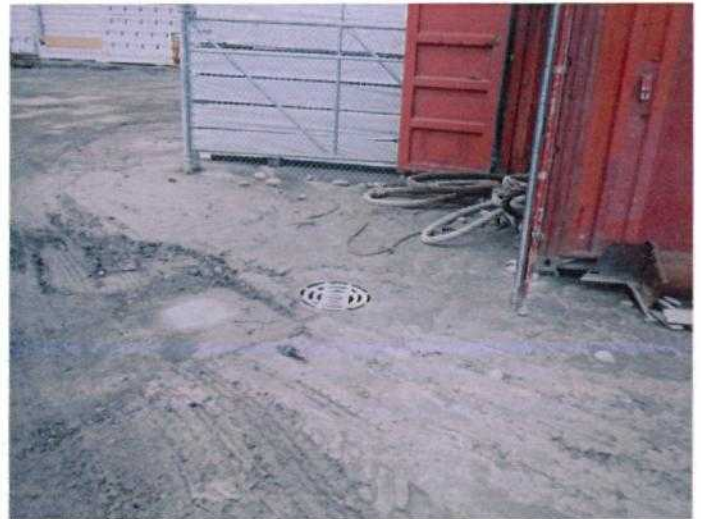
Photo #:02

Description: Photo of the north east catch basin. This catch basin is the first in a series of four catch basins that combine and discharge to the north outfall.

Catch basins BMPs observed at the time of inspection included adsorbent booms, the majority of the booms required maintenance and many catch basins did not have any BMPs in place. See Attachment E, Photo Log, Photo #02, #05, #13, #14, #18, #19 #21.

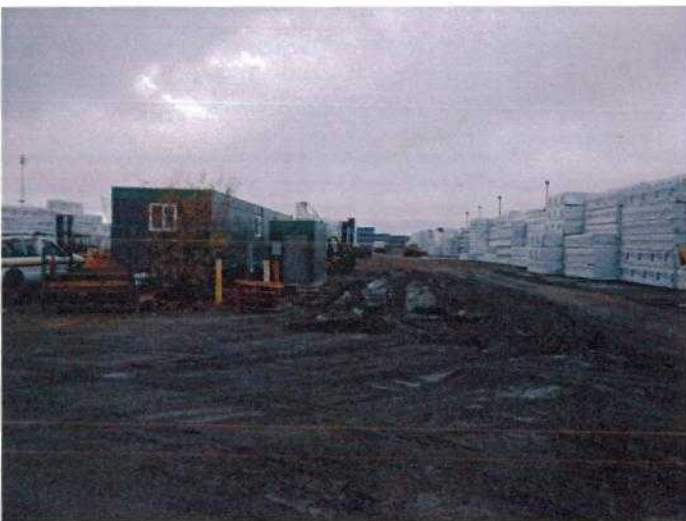
Photo #:03

Description: Facing west, photo of the finished lumber storage area. According to the facility this area is subleased by Bernard's Builder Supply. Stormwater from this area is primarily infiltrated. Camera Photo DSCN1141.

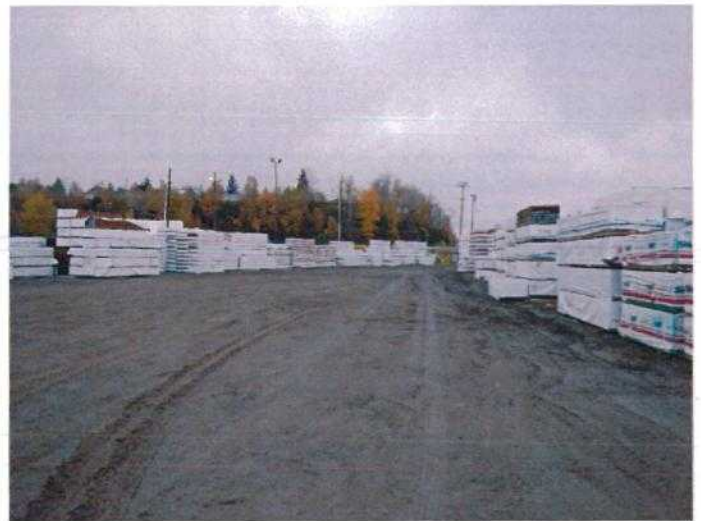
Photo #:04

Description: Facing east, photo of the finished lumber storage area. According to the facility, this area is subleased by Bernard's Builder Supply. Stormwater from this area is primarily infiltrated. Camera Photo DSCN1142.

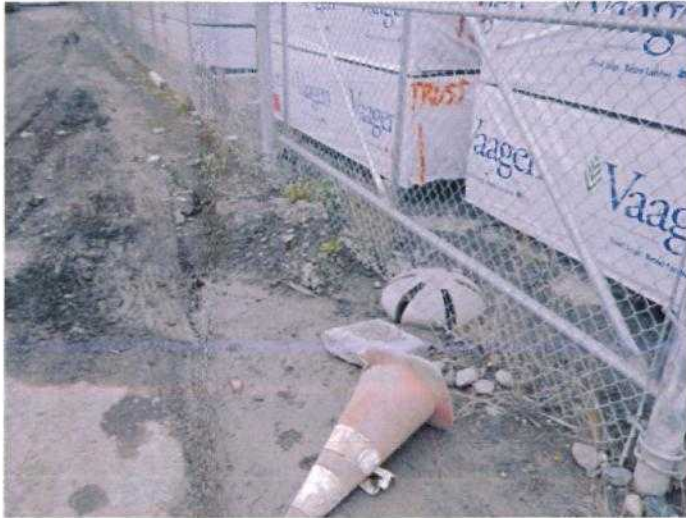
Photo #:05

Description: Photo of a catch basin with inlet cover just north of the main office. This catch basin is the third in a series of four catch basins that combine and discharge to the north outfall. Camera Photo DSCN1143.

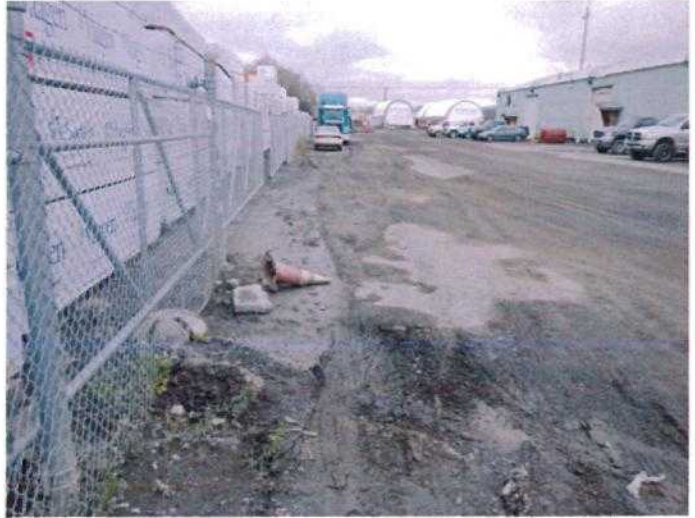
Photo #:06

Description: Facing east, photo of a catch basin with inlet cover just north of the main office. This catch basin is the third in a series of four catch basins that combine and discharge to the north outfall. Camera Photo DSCN1144.

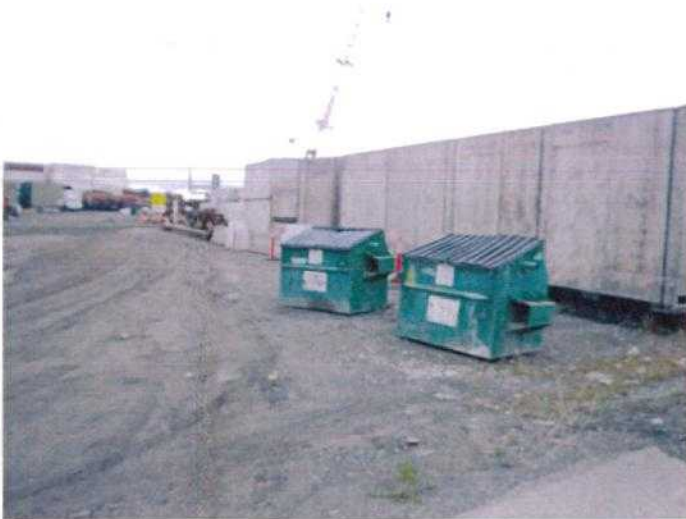
Photo #:07

Description: Facing west, photo of covered dumpsters located just west of the main office. Camera Photo DSCN1145.

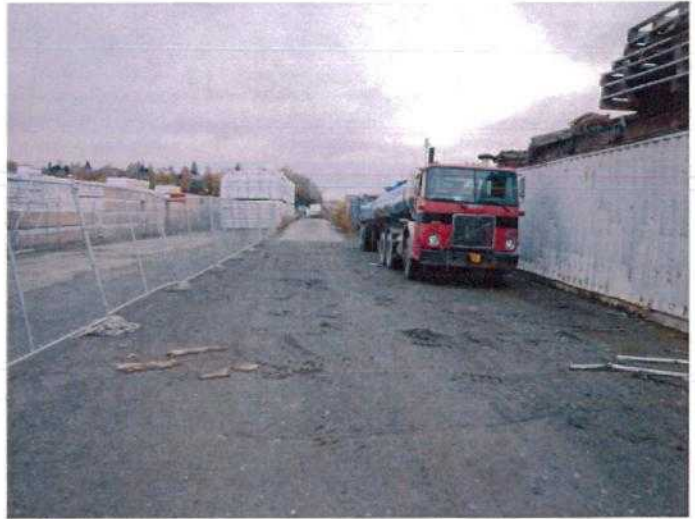
Photo #:08

Description: Facing east, photo of the area near the fourth and last catch basin in the series of catch basins that discharge to the north outfall. This catch basin also the designated sampling location for the north outfall. The catch basin is located just left of the parked red vehicle. Camera Photo DSCN1146.

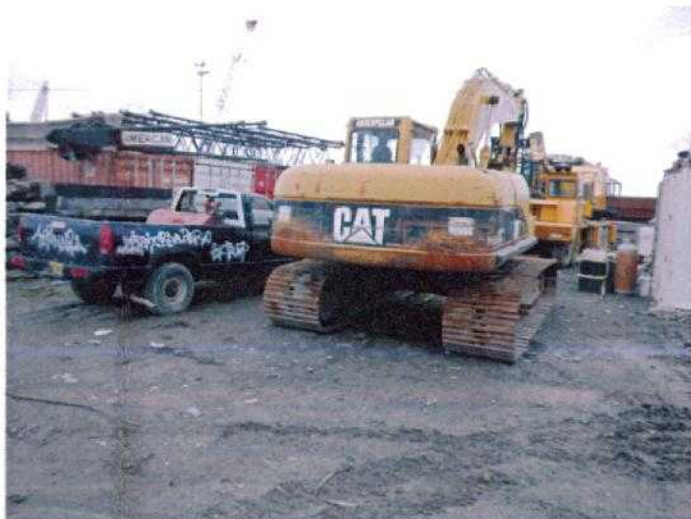
Photo #:09

Description: Facing west, photo of a subleased area used for material storage. Camera Photo DSCN1147.

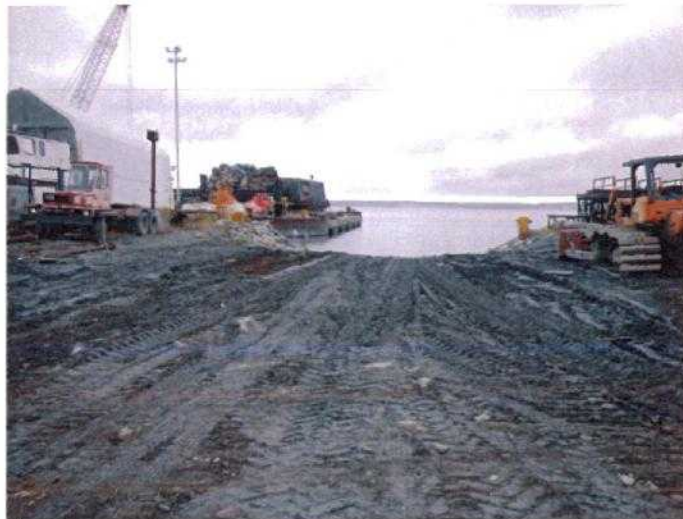
Photo #:10

Description: Facing west, photo of the just east of the loading ramp and northeast of the dock. This area acts as dredging access for the facility's bulldozer. The facility provided me with U.S. Army Corps of Engineer dredging permit. Camera Photo DSCN1148.

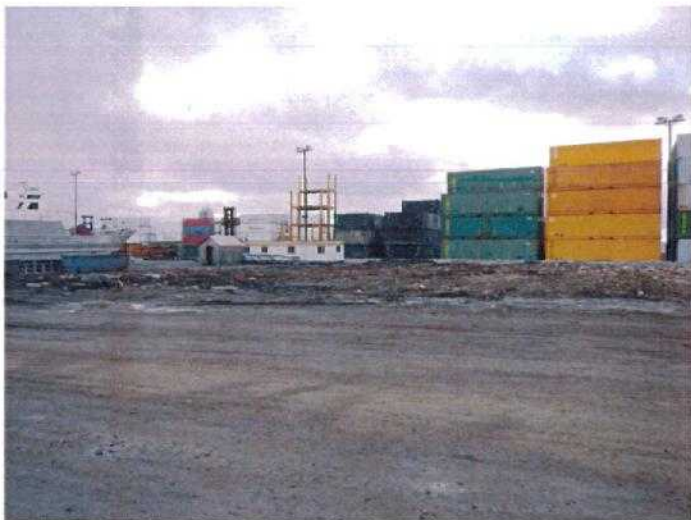
Photo #:11

The concern is the lack of BMPs and/or BMP maintenance in relation to the activity that occurs at this location. See Attachment E, Photo Log, Photo #11, #17 & #18.

Description: Facing south, photo of the area that was historically subleased to Schnitzer Steel for scrap metal storage. Camera Photo DSCN1149.

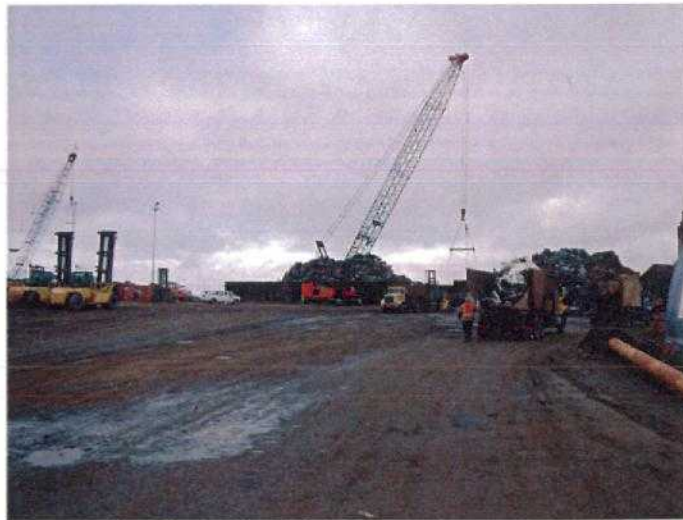
Photo #:12

Description: Facing west, photo of activity occurring during the inspection. Loading of scrap metal to a barge at the dock. Camera Photo DSCN1150.

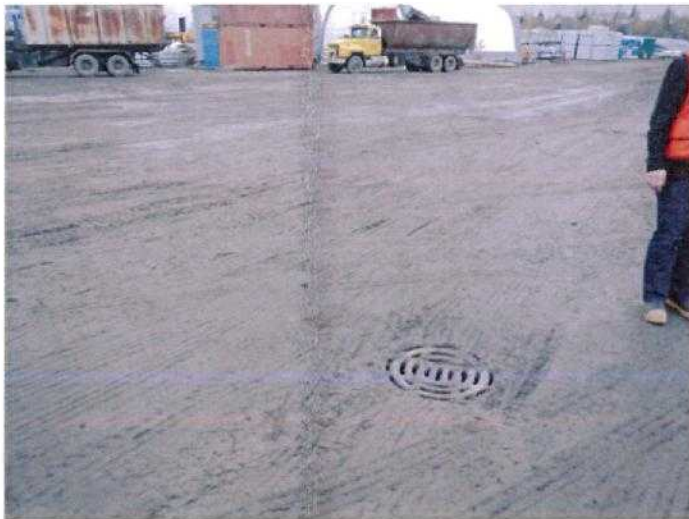
Photo #:13

Description: Facing northeast, photo of a catch basin near the loading dock. This catch basin is the final one in a series of five that discharge to the south outfall. This is also the sampling location for the south outfall. Camera Photo DSCN1151.

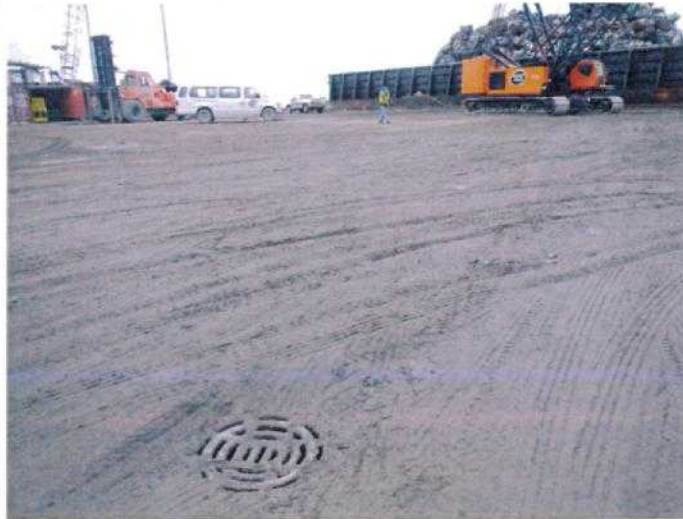
Photo #:14

Description: Facing west, photo of a catch basin near the loading dock. This catch basin is the final one in a series of five that discharge to the south outfall. This is also the sampling location for the south outfall. Camera Photo DSCN1152.

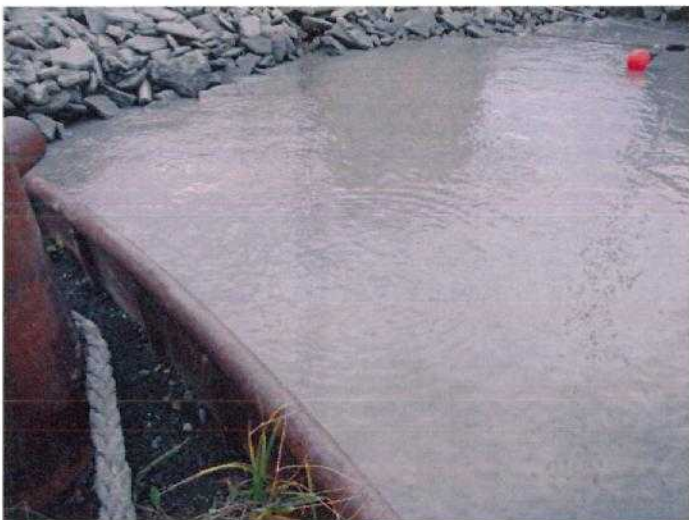
Photo #:15

Description: Facing south near the loading dock, photo of the location of the south outfall. The outfall is a pipe underwater that discharges to Knik Arm of Cook Inlet. According to the facility you can view the pipe during low tide. Camera Photo DSCN1153.

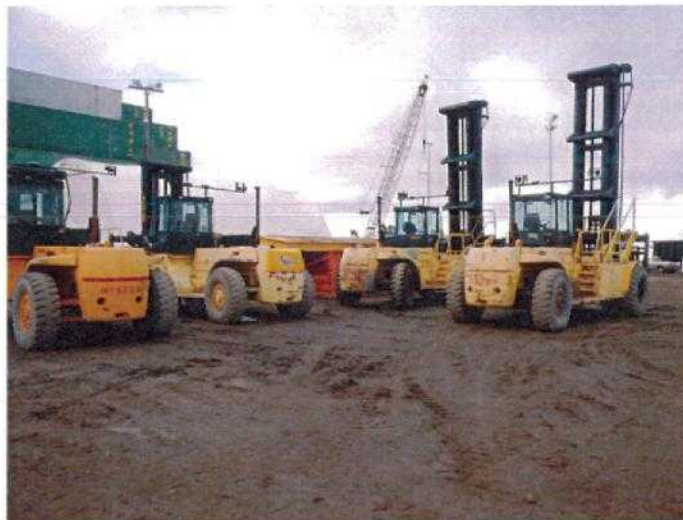
Photo #:16

Description: Facing west, photo of fork lift staging area, this area is located just east of the loading dock. DSCN1154.

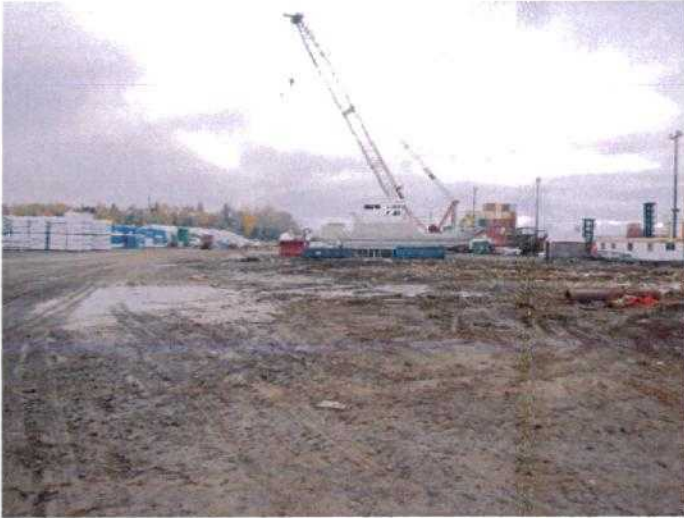
Photo #:17

Description: Facing east, photo of the area that was historically subleased to Schnitzer Steel for scrap metal storage. Camera Photo DSCN1155.

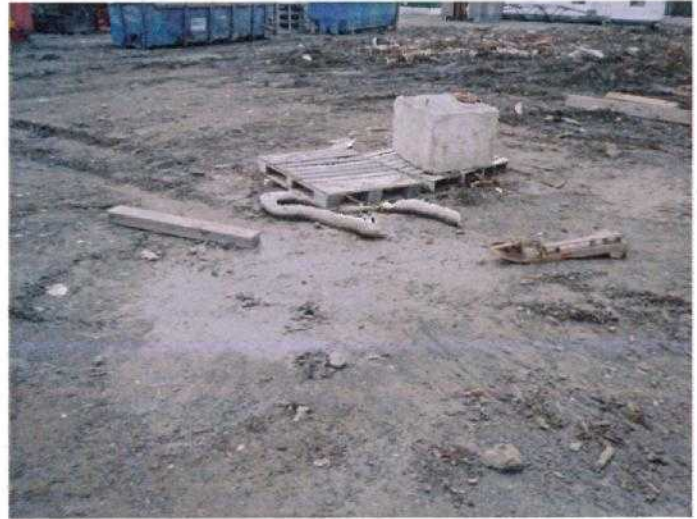
Photo #:18

Description: Facing south, photo of the area that was historically subleased to Schnitzer Steel for scrap metal storage. A catch basin is located under the wood pallet near the white boom. This catch basin discharges to the south outfall. Camera Photo DSCN1156.

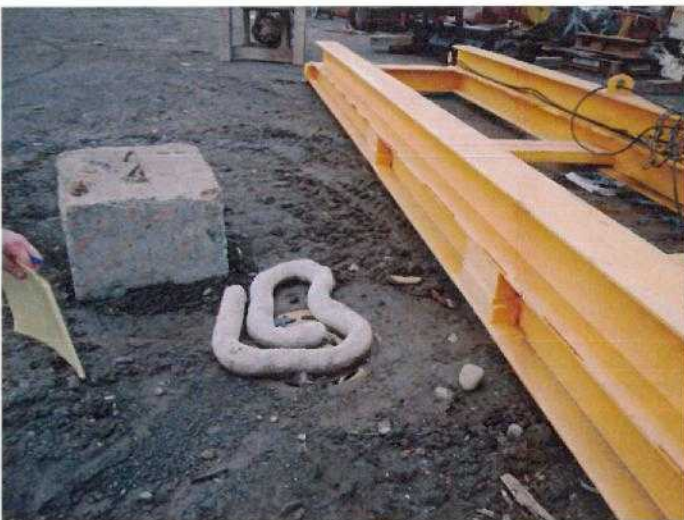
Photo #:19

Description: Facing south, photo of a catch basin along the southern end of the facility near a material storage area. This catch basin discharges to the south outfall. Camera Photo DSCN1157.

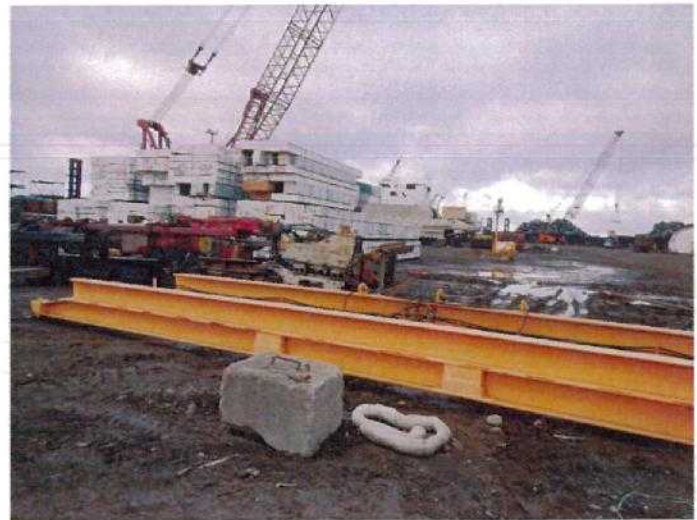
Photo #:20

Description: Facing west, photo of a catch basin along the southern end of the facility near a material storage area. This catch basin discharges to the south outfall. Camera Photo DSCN1158.

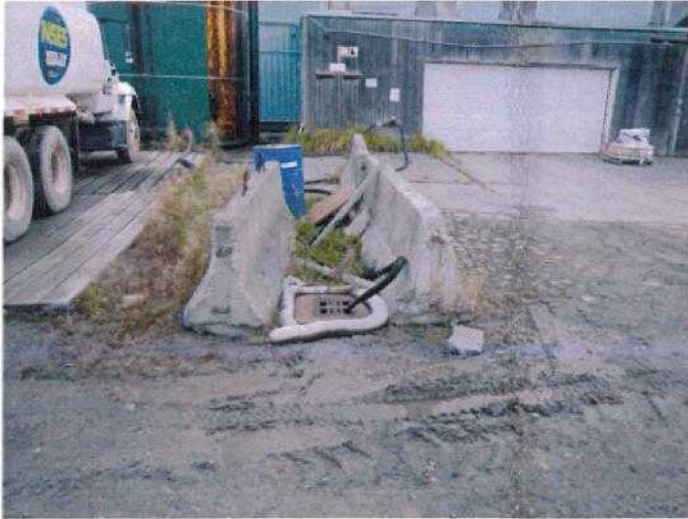
Photo #:21

Description: Facing north, photo of the hose discharging Class C Drinking Well Water to the stormwater catch basin. According to the facility this is a continuous discharge. Camera Photo DSCN1159.

At the time of inspection, it was observed that the facility has an on-site Class C drinking water well that has a constant discharge to a stormwater catch basin located just south of the main office. The water from the well comingles with stormwater and eventually discharges to the South Outfall. See Attachment E, Photo Log, Photo #21. The Class C well water discharge is described on page 6 of the facility’s SWPPP which is attached to this report as Attachment E.

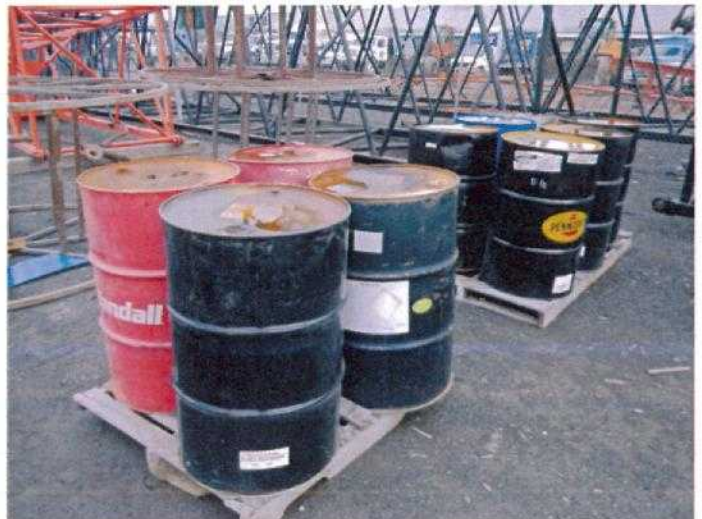
Photo #:22

Description: Photo of a material storage area. The drums pictured were empty at the time of inspection. Camera Photo DSCN1160.

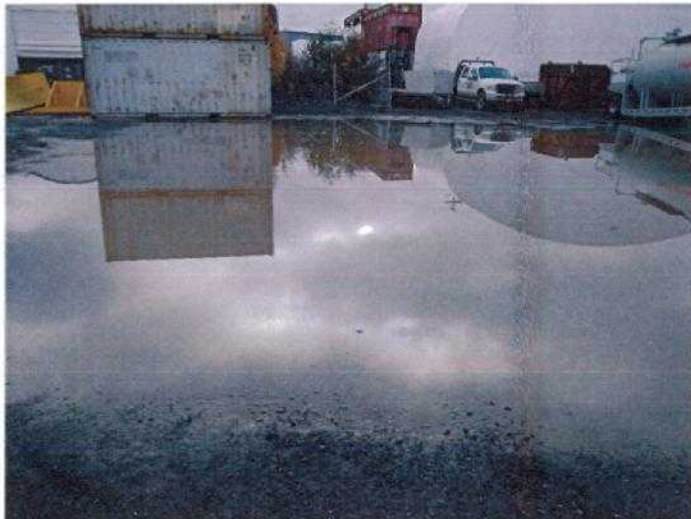
Photo #:23

Description: Facing east, photo of the southeast storage area and ponded water at this location. Camera Photo DSCN1161.

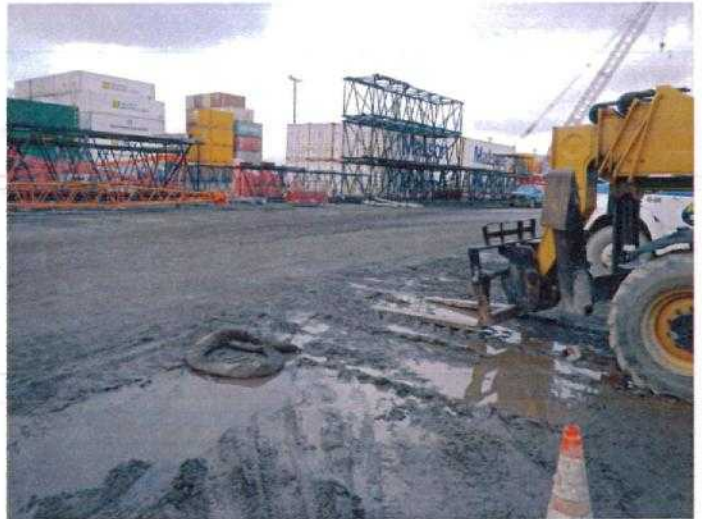
Photo #:24

Description: Facing southwest, photo of the southeast catch basin near the pressure washing area. Camera Photo DSCN1162.

At the time of inspection, I observed a buildup of sediment/material at the wash down area. A stormwater catch basin is located approximately 25 feet away. The catch basin had an adsorbent boom around which was in need of maintenance. No controls were in place to prevent water from the pressure washing area from discharging into the stormwater collection system. See Attachment E, Photo Log, Photo #24 & #25.
